**Flood Control Project Maintenance
Levee Inspections**
LMA District Cover Sheet
Spring 2018 Levee Inspection Results

Reclamation District No. 0003 Grand Island

Spring 2018 Levee Inspection Results

| Waterway | | | Bank | Unit Miles |
|--|---|---|---|---|
| Unit No. 01 Left Bank Steamboat Slough | | | Left | 10.95 |

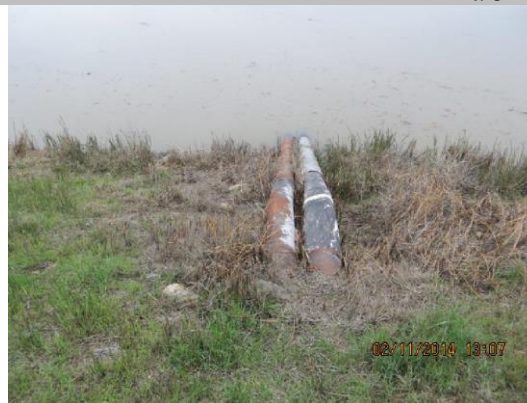
Photo 1 of 3 : UCIP_SP_2018_50428_54124.jpg

| FS_ID:50428 DS_ID:22346 EP_NO: N/A Repair Type: Non-Urgent Crossing Status: Found UCIP Comments: 07/06/2016 Same as last inspection. Annular space needs to be grouted per Title 23. This crossing has been downgraded from Urgent to Non-Urgent because the hole created in the conduit sleeve was deliberate and not a sign of pipe failure. Pipe was flowing at the time of the inspection (possibly via a portable pump). (DWR UCIP - K. Fazel)02/11/2014 Pipe cut open on LS shoulder and along slope. 3.5-inch PVC pipe sleeved through with 2 vents with valves. Pipe annular space not grouted. (DWR FPIIB - G. Wylie) FIELD_STRUCT_DESC: 1 of 2: 12-inch steel irrigation siphon through the levee, invert elevation 3 feet below the crown. Siphon breaker on the landside (LS) shoulder. 3.5-inch polyvinyl chloride (PVC) pipe sleeved through the existing 12-inch pipe. (Vic Romanini). [Additional Reference(s): DWR Levee Log, 1993. USACE Sacramento O&M Manual 104, February 1960, (RM 19.06)]. FS Date: 7/6/2016 | | | | | |

Steel pipe visible on WS slope

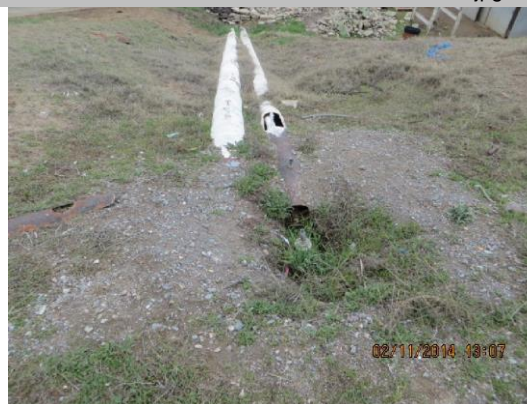
Photo 2 of 3 : UCIP_SP_2018_50428_54123.jpg

Pipe visible on LS slope with cuts at two places.

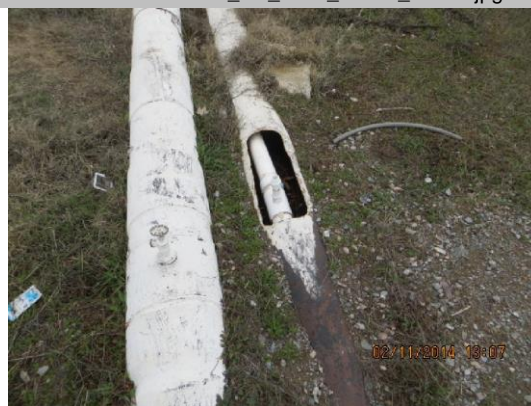
Photo 3 of 3 : UCIP_SP_2018_50428_54122.jpg

| FS_ID:50428 DS_ID:22346 EP_NO: N/A Repair Type: Non-Urgent Crossing Status: Found UCIP Comments: 07/06/2016 Same as last inspection. Annular space needs to be grouted per Title 23. This crossing has been downgraded from Urgent to Non-Urgent because the hole created in the conduit sleeve was deliberate and not a sign of pipe failure. Pipe was flowing at the time of the inspection (possibly via a portable pump). (DWR UCIP - K. Fazel)02/11/2014 Pipe cut open on LS shoulder and along slope. 3.5-inch PVC pipe sleeved through with 2 vents with valves. Pipe annular space not grouted. (DWR FPIIB - G. Wylie) FIELD_STRUCT_DESC: 1 of 2: 12-inch steel irrigation siphon through the levee, invert elevation 3 feet below the crown. Siphon breaker on the landside (LS) shoulder. 3.5-inch polyvinyl chloride (PVC) pipe sleeved through the existing 12-inch pipe. (Vic Romanini). [Additional Reference(s): DWR Levee Log, 1993. USACE Sacramento O&M Manual 104, February 1960, (RM 19.06)]. FS Date: 7/6/2016 | | | | | | |

3.5-inch PVC pipe sleeved through pipe on LS shoulder.

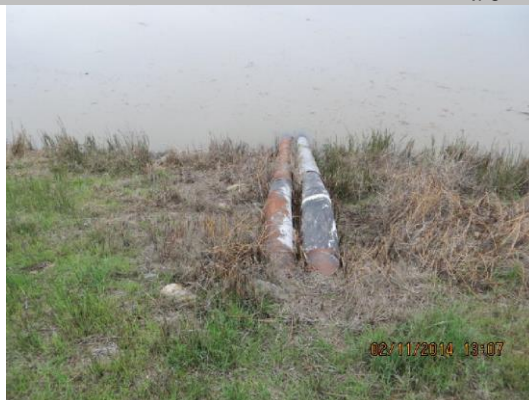
Photo 1 of 3 : UCIP_SP_2018_50427_54133.jpg

FS_ID:50427
DS_ID:22180
EP_NO: N/A
Repair Type: Non-Urgent
Crossing Status: Found
UCIP Comments: 07/06/2016 Same as last inspection. Annular space needs to be grouted per Title 23. This crossing has been downgraded from Urgent to Non-Urgent because the deformed nature of the pipe is not indicative of imminent failure. (DWR UCIP - K. Fazel)02/11/2014 Pipe sleeved with a PVC pipe that is crushed on the WS slope. Annular space not grouted. (DWR FPIIB - G. Wylie)
FIELD_STRUCT_DESC: 2 of 2: 14-inch steel irrigation siphon through the levee, invert elevation 3.1 feet below the crown. Siphon breaker on the landside (LS) shoulder. 14-inch pipe sleeved with a smaller diameter polyvinyl chloride (PVC) pipe. (Vic Romanini). [Additional Reference(s): DWR Levee Log, 1993, referenced as 3 feet below the crown. USACE Sacramento O&M Manual 104, February 1960, (RM 19.06)].
FS Date: 7/6/2016

Pipe visible on WS slope, PVC pipe exposed and crushed on WS slope.

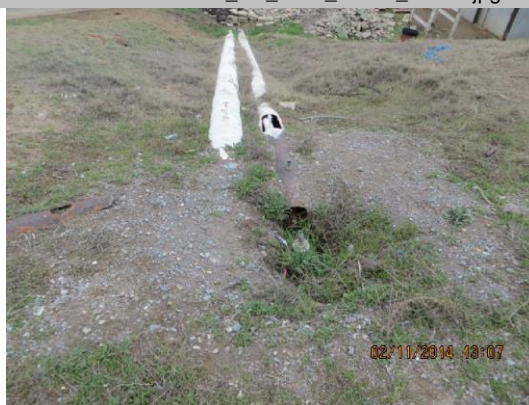
Photo 2 of 3 : UCIP_SP_2018_50427_54132.jpg

PVC pipe visible on LS slope.

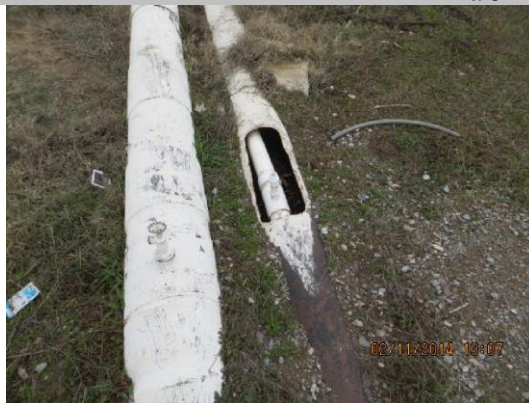
Photo 3 of 3 : UCIP_SP_2018_50427_54131.jpg

| FS_ID:50427 DS_ID:22180 EP_NO: N/A Repair Type: Non-Urgent Crossing Status: Found UCIP Comments: 07/06/2016 Same as last inspection. Annular space needs to be grouted per Title 23. This crossing has been downgraded from Urgent to Non-Urgent because the deformed nature of the pipe is not indicative of imminent failure. (DWR UCIP - K. Fazel)02/11/2014 Pipe sleeved with a PVC pipe that is crushed on the WS slope. Annular space not grouted. (DWR FPIIB - G. Wylie) FIELD_STRUCT_DESC: 2 of 2: 14-inch steel irrigation siphon through the levee, invert elevation 3.1 feet below the crown. Siphon breaker on the landside (LS) shoulder. 14-inch pipe sleeved with a smaller diameter polyvinyl chloride (PVC) pipe. (Vic Romanini). [Additional Reference(s): DWR Levee Log, 1993, referenced as 3 feet below the crown. USACE Sacramento O&M Manual 104, February 1960, (RM 19.06)]. FS Date: 7/6/2016 | | | | | | |

Siphon breaker on PVC pipe on LS slope.

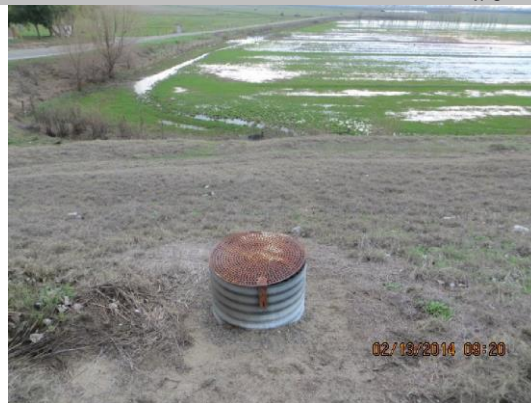
Photo 1 of 2 : UCIP_SP_2018_29924_55248.jpg

| FS_ID:29924 DS_ID:22181 EP_NO: N/A Repair Type: Non-Urgent Crossing Status: Found UCIP Comments: Pipe appears abandoned and should be verified as having been done so properly. FIELD_STRUCT_DESC: 12-inch steel irrigation siphon through the levee, invert elevation 3 feet below the crown. Siphon breaker in a 24-inch corrugated metal pipe (CMP) riser on the landside (LS) shoulder. 4-foot concrete standpipe at the LS toe. (Vic Romanini). [Additional Reference(s): DWR Levee Log, 1993. USACE Sacramento O&M Manual 104, February 1960, (RM 18.89)]. FS Date: 2/11/2014 | | | | | |

Siphon breaker in CMP riser on LS shoulder.

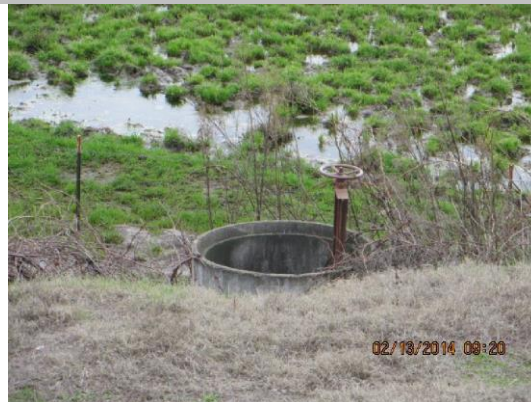
Photo 2 of 2 : UCIP_SP_2018_29924_55247.jpg

Concrete standpipe on LS toe.

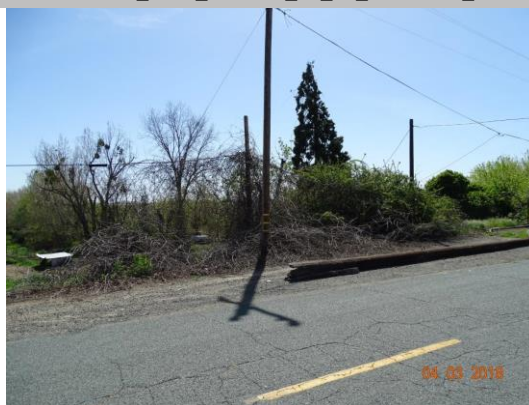
Photo 1 of 1 : SP_2018_RD0003_24_90_20180403_00181.jpg

Landside landscaping inhibits inspection and access.

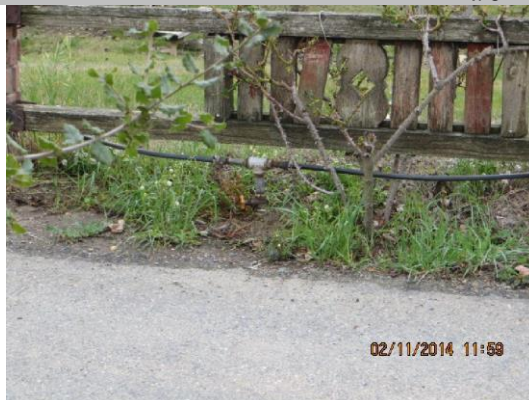
Photo 1 of 3 : UCIP_SP_2018_31283_57282.jpg

| FS_ID:31283 DS_ID:24836 EP_NO: N/A Repair Type: Non-Urgent Crossing Status: Found UCIP Comments: No permit identified for this crossing. FIELD_STRUCT_DESC: 2.5-inch galvanized iron irrigation pipe through the levee, at an unknown depth. Pipe and spigot visible at the waterside (WS) toe. A second spigot on the landside (LS) slope. This crossing was field discovered. FS Date: 2/11/2014 | | | | | |

Shutoff valve next to LS ramp

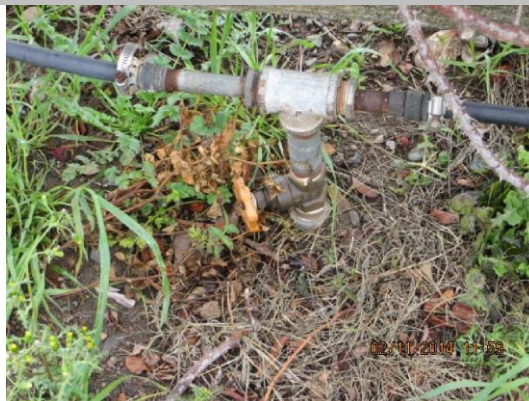
Photo 2 of 3 : UCIP_SP_2018_31283_57281.jpg

Shutoff valve next to LS ramp

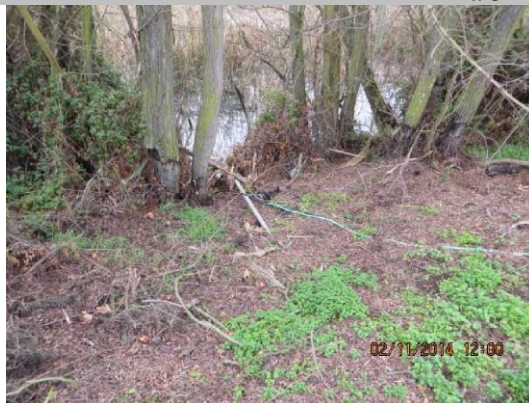
Photo 3 of 3 : UCIP_SP_2018_31283_57280.jpg

| FS_ID:31283 DS_ID:24836 EP_NO: N/A Repair Type: Non-Urgent Crossing Status: Found UCIP Comments: No permit identified for this crossing. FIELD_STRUCT_DESC: 2.5-inch galvanized iron irrigation pipe through the levee, at an unknown depth. Pipe and spigot visible at the waterside (WS) toe. A second spigot on the landside (LS) slope. This crossing was field discovered. FS Date: 2/11/2014 | | | | | | |

Pipe visible at WS toe.

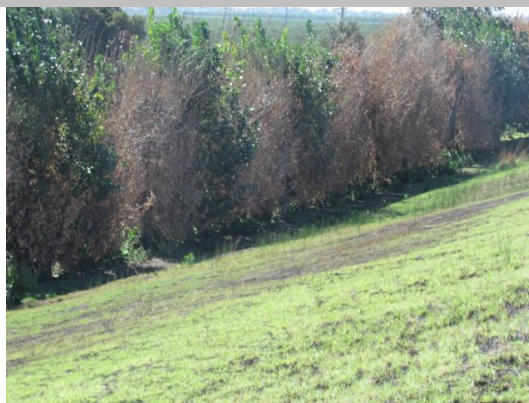
Photo 1 of 3 : SP_2018_RD0003_24_78_20180305_00069.jpg

| Trees within 10' of levee toe obstruct access and visibility of levee toe. | | | | | |

Looking eastly at trees blocking view of landward toe. (Fall 2015)

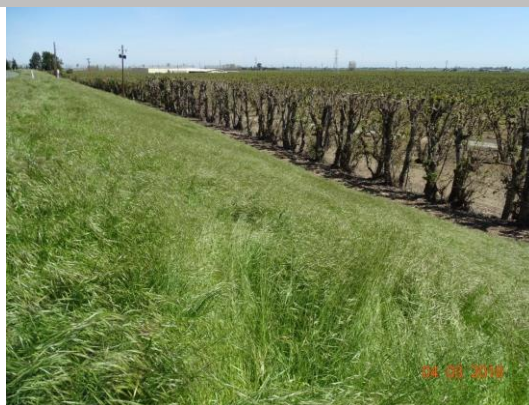
Photo 3 of 3 : SP_2018_RD0003_24_78_20180403_00182.jpg

Closely spaced trees along toe.

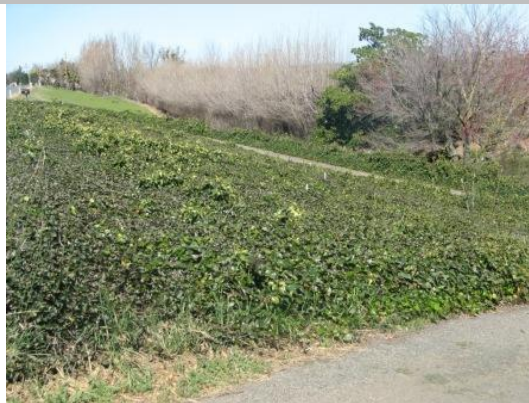
Photo 1 of 1 : SP_2018_RD0003_24_25_20180305_00028.jpg

| Owner is in the process of removing thick landscaping on 4/3/2018. | | | | | |

Landscaping (Ivy) on landside slope blocking view of levee from LM 7.89
to 7.94

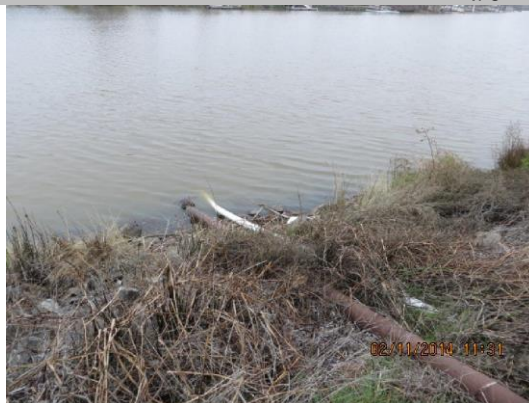
Photo 1 of 3 : UCIP_SP_2018_29235_54053.jpg

FS_ID:29235
DS_ID:22186
EP_NO: 2225
Repair Type: Non-Urgent
Crossing Status: Found
UCIP Comments: CMP riser knocked over and no sign of siphon breaker.
FIELD_STRUCT_DESC: 8-inch steel irrigation discharge pipe through the levee, invert elevation 3.5 feet below the crown. Service pole and siphon breaker in a corrugated metal pipe (CMP) riser on the landside (LS) slope. Pump in a pump house and a booster pump on a concrete slab on the waterside (WS) slope. (Plans to install an 8-inch irrigation pipe through the levee and an inclined pump on the WS slope authorized under Permit No. 2225, 1955 - Fay Ranch, Captain N. A. Fay, care of The River Lines, Inc. USACE Unit No. 10, new pipe installed in 1967). [Additional Reference(s): DWR Levee Log, 1993. USACE Sacramento O&M Manual 104, February 1960, (17.92)].
FS Date: 2/11/2014

Pipe visible on WS toe.

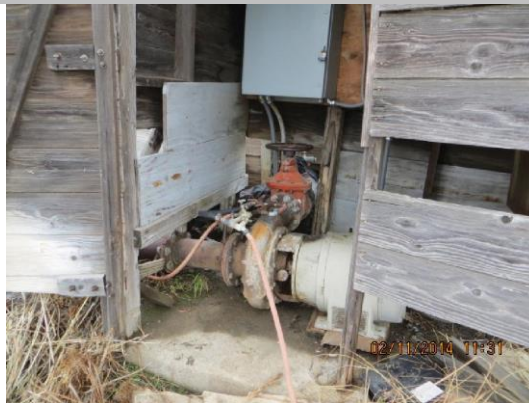
Photo 2 of 3 : UCIP_SP_2018_29235_54052.jpg

Pump and gate valve visible inside pumphouse on WS shoulder.

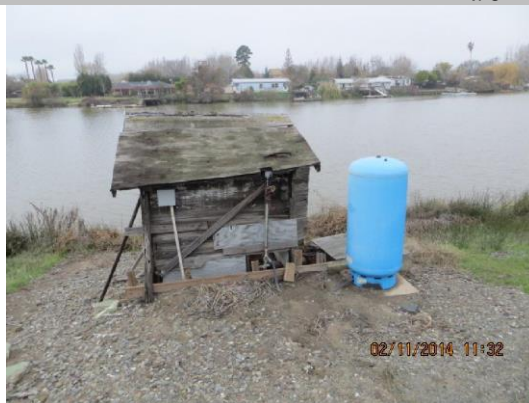
Photo 3 of 3 : UCIP_SP_2018_29235_54051.jpg

| FS_ID:29235 DS_ID:22186 EP_NO: 2225 Repair Type: Non-Urgent Crossing Status: Found UCIP Comments: CMP riser knocked over and no sign of siphon breaker. FIELD_STRUCT_DESC: 8-inch steel irrigation discharge pipe through the levee, invert elevation 3.5 feet below the crown. Service pole and siphon breaker in a corrugated metal pipe (CMP) riser on the landside (LS) slope. Pump in a pump house and a booster pump on a concrete slab on the waterside (WS) slope. (Plans to install an 8-inch irrigation pipe through the levee and an inclined pump on the WS slope authorized under Permit No. 2225, 1955 - Fay Ranch, Captain N. A. Fay, care of The River Lines, Inc. USACE Unit No. 10, new pipe installed in 1967). [Additional Reference(s): DWR Levee Log, 1993. USACE Sacramento O&M Manual 104, February 1960, (17.92)]. FS Date: 2/11/2014 | | | | | | |

Pump and tank on WS shoulder.

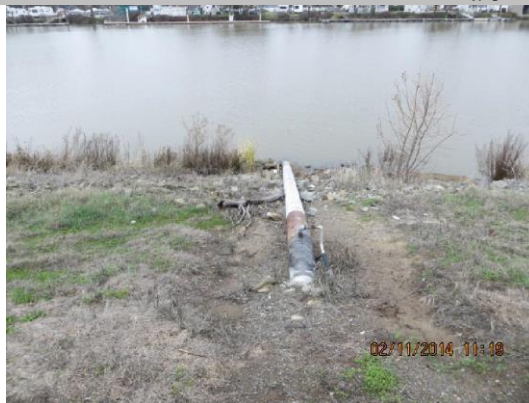
Photo 1 of 3 : UCIP_SP_2018_29233_54047.jpg

| UCIP Comments: Siphon breaker and CMP riser missing from LS slope. | | | | | | |

Pipe visible on WS slope.

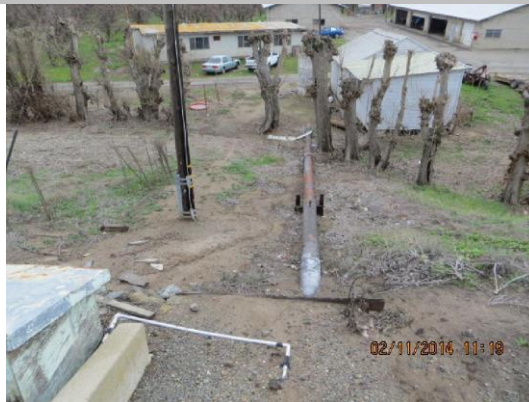
Photo 2 of 3 : UCIP_SP_2018_29233_54046.jpg

Pipe, pumphouse, and standpipe visible on LS slope.

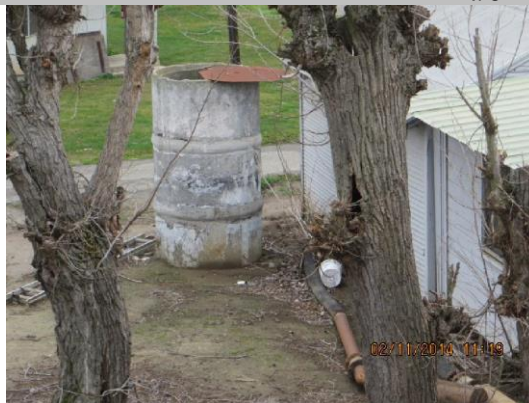
Photo 3 of 3 : UCIP_SP_2018_29233_54045.jpg

| UCIP Comments: Siphon breaker and CMP riser missing from LS slope. | | | | | | |

Concrete standpipe on LS toe.

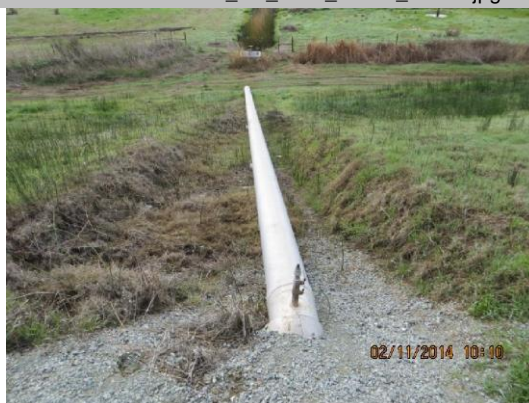
Photo 1 of 3 : UCIP_SP_2018_29187_53952.jpg

| FS_ID:29187 DS_ID:22202 EP_NO: N/A Repair Type: Non-Urgent Crossing Status: Found UCIP Comments: Annular space between 12 and 14-inch pipes not grouted. FIELD_STRUCT_DESC: 14-inch steel irrigation siphon through the levee, invert elevation 2.9 feet below the crown. 14-inch pipe sleeved with a 12-inch pipe. Vent and siphon breaker on the landside (LS) shoulder. Concrete distribution box and gate valve at the LS toe. [Additional Reference(s): DWR Levee Log, 1993, referenced as a 16-inch pipe sleeved with a 12-inch pipe. USACE Sacramento O&M Manual 104, February 1960, (RM 16.92), referenced as a 16-inch pipe sleeved with a 14-inch pipe]. FS Date: 2/11/2014 11:00:22 AM | | | | | |

Pipe, siphon breaker/vent, and distribution box visible on LS.

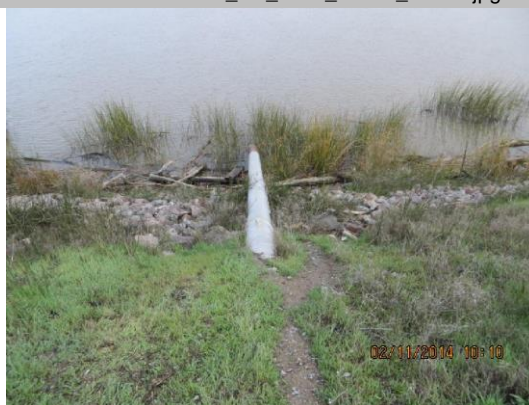
Photo 2 of 3 : UCIP_SP_2018_29187_53951.jpg

Pipe visible on WS slope.

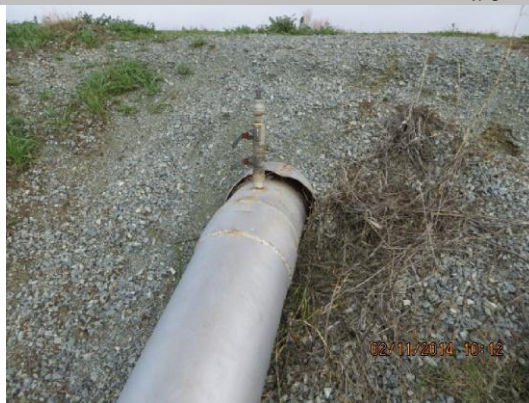
Photo 3 of 3 : UCIP_SP_2018_29187_53950.jpg

| FS_ID:29187 DS_ID:22202 EP_NO: N/A Repair Type: Non-Urgent Crossing Status: Found UCIP Comments: Annular space between 12 and 14-inch pipes not grouted. FIELD_STRUCT_DESC: 14-inch steel irrigation siphon through the levee, invert elevation 2.9 feet below the crown. 14-inch pipe sleeved with a 12-inch pipe. Vent and siphon breaker on the landside (LS) shoulder. Concrete distribution box and gate valve at the LS toe. [Additional Reference(s): DWR Levee Log, 1993, referenced as a 16-inch pipe sleeved with a 12-inch pipe. USACE Sacramento O&M Manual 104, February 1960, (RM 16.92), referenced as a 16-inch pipe sleeved with a 14-inch pipe]. FS Date: 2/11/2014 11:00:22 AM | | | | | | |

Annular space not grouted between pipes.

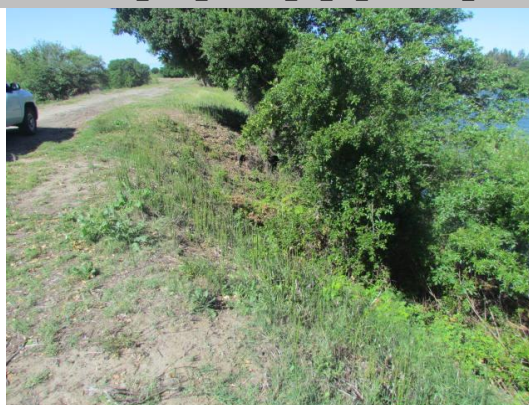
Photo 1 of 2 : SP_2018_RD0003_24_97_20180305_00081.jpg

| Erosion extends to waterward shoulder. | | | | | |

Looking south at erosion on waterward slope.

| E2 : Schedule repair of erosion site prior to the next inspection. | | | | | |

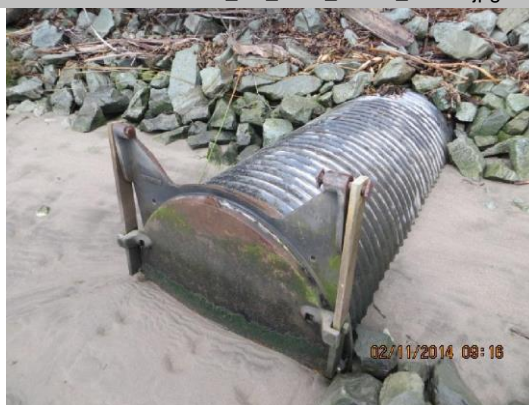
Photo 1 of 3 : UCIP_SP_2018_29165_53866.jpg

| FS_ID:29165 DS_ID:22206 EP_NO: N/A Repair Type: Non-Urgent Crossing Status: Found UCIP Comments: Pipe appears abandoned and should be verified as having been done so properly. FIELD_STRUCT_DESC: *ABANDONED* 1 of 3: 36-inch corrugated metal drainage pipe through the levee, 15 feet below the crown. Slide gate in a 48-inch corrugated metal pipe (CMP) riser on the waterside (WS) shoulder. Flap gate at the WS toe has been sealed shut with sealant. [Additional Reference(s): DWR Levee Log, 1993, referenced as 24 feet below the crown. USACE Sacramento O&M Manual 104, February 1960, (RM 15.20), referenced as invert elevation 24 feet below the crown]. FS Date: 2/11/2014 | | | | | |

36-inch CMP drainpipe with flapgate on WS toe.

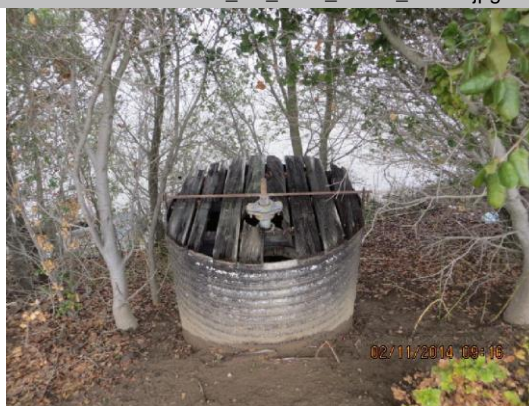
Photo 2 of 3 : UCIP_SP_2018_29165_53865.jpg

Slide gate in 48-inch CMP riser on WS shoulder.

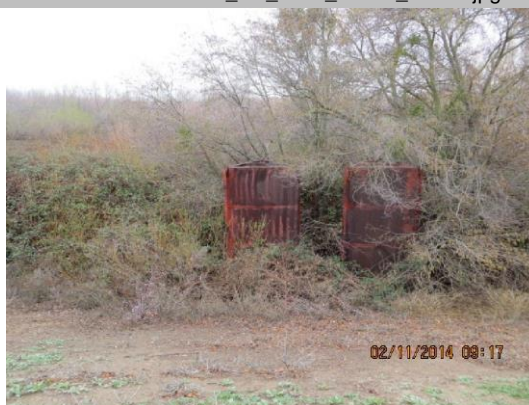
Photo 3 of 3 : UCIP_SP_2018_29165_53864.jpg

Steel weir on LS toe.

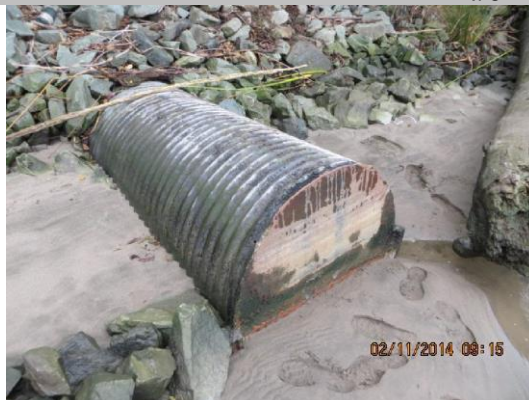
Photo 1 of 3 : UCIP_SP_2018_29164_53862.jpg

Drainpipe visible on WS toe with steel plate welded over end.

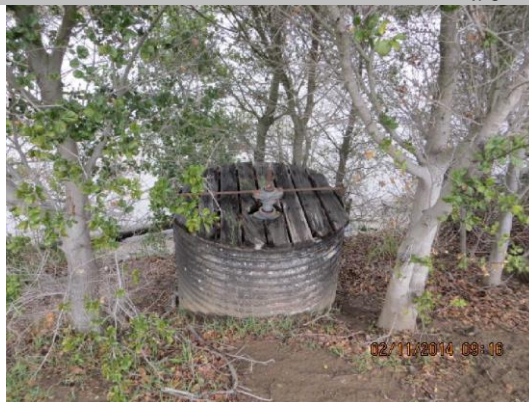
Photo 2 of 3 : UCIP_SP_2018_29164_53861.jpg

48-inch CMP riser with slide gate closed on WS shoulder.

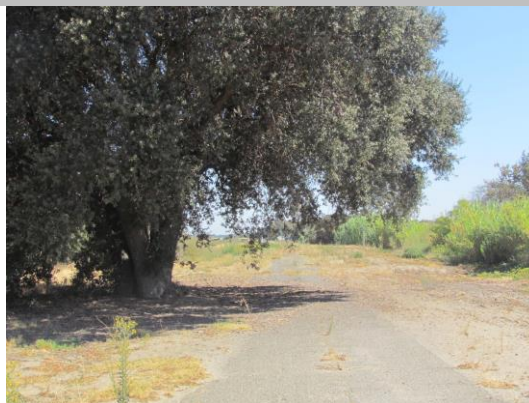
Photo 1 of 1 : SP_2018_RD0003_25_4_20180305_00006.jpg

Looking east at untrimmed tree on landward shoulder.

| Trim tree at least 12 feet above ground on levee crown. | | | | | |

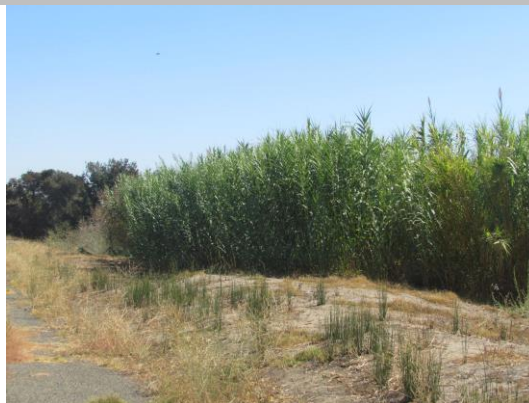
Photo 1 of 2 : SP_2018_RD0003_25_5_20180305_00007.jpg

| Bamboo sprouts on waterward slope. | | | | | |

Looking southeast at bamboo on waterward slope. (Fall 2016)

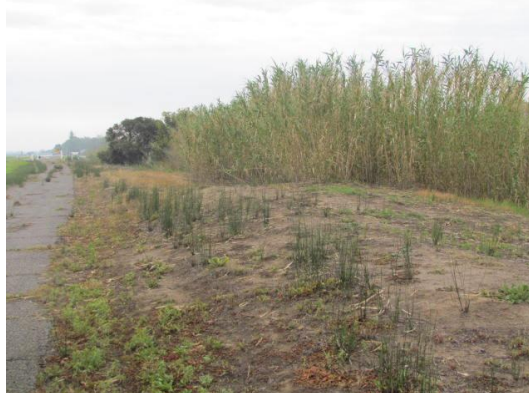
Photo 2 of 2 : SP_2018_RD0003_25_5_20180305_00008.jpg

| Bamboo sprouts on waterward slope. | | | | | | |

Looking east at bamboo on waterward slope. (Spring 2016)

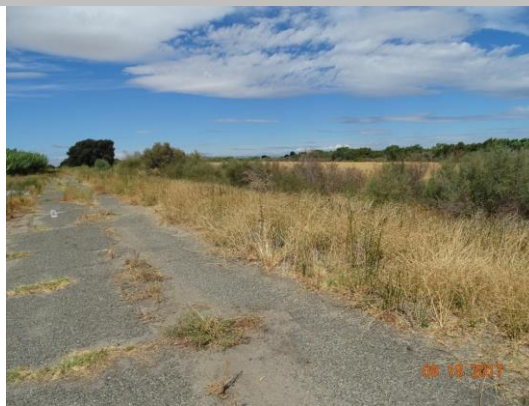
Photo 1 of 2 : SP_2018_RD0003_25_151_20180305_00129.jpg

Looking west at landside slope.

| Remove young willows along landside toe. | | | | | |

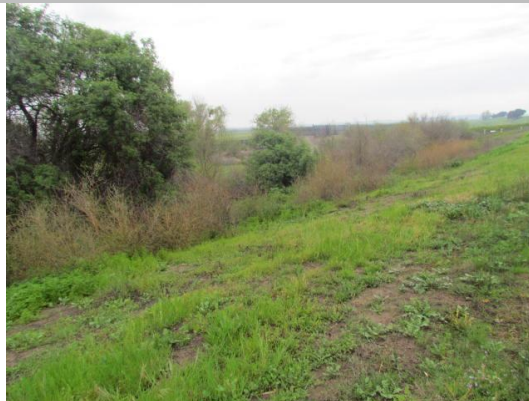
Photo 2 of 2 : SP_2018_RD0003_25_151_20180305_00130.jpg

Looking west at dense vegetation at landward toe.

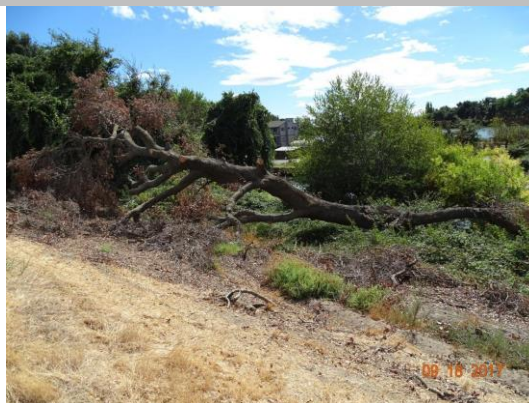
Photo 1 of 3 : SP_2018_RD0003_25_129_20180305_00093.jpg

| Large fallen tree on waterside slope. | | | | | |

Looking east at waterside slope.

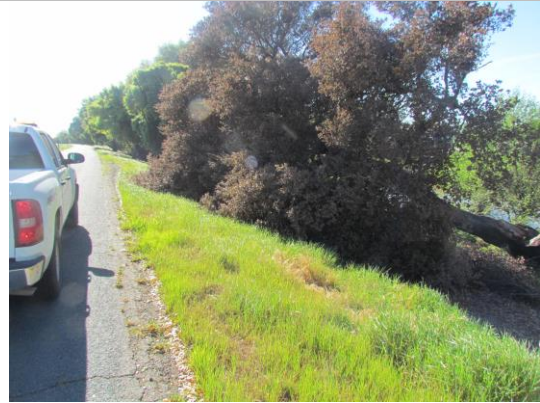
Photo 3 of 3 : SP_2018_RD0003_25_129_20180305_00095.jpg

| Large fallen tree on waterside slope. | | | | | | |

Looking northeast at fallen tree on waterward slope.

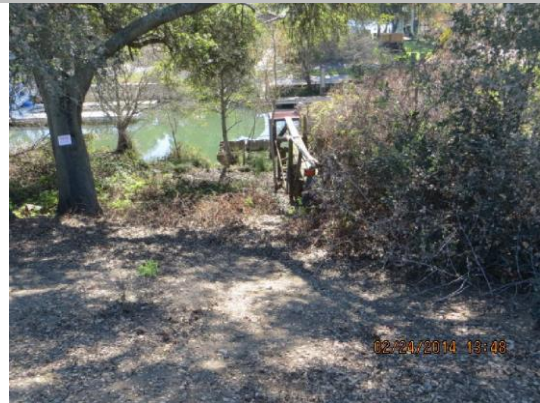
Photo 1 of 3 : UCIP_SP_2018_31083_56982.jpg

| FS_ID:31083 DS_ID:22209 EP_NO: 1647 Repair Type: Non-Urgent Crossing Status: Found UCIP Comments: Sag in pavement over pipe on crown and wooden walkway to pump falling apart. Good candidate for video inspection. FIELD_STRUCT_DESC: 10-inch steel irrigation discharge pipe through the levee, invert elevation 5.8 feet below the crown. Pump on a pile structure in the channel. Service pole on the landside (LS) slope. 1.5-inch electrical conduit through the levee, 3 feet below the crown. 42-inch concrete standpipe at the LS toe. (Plans for installing a 1.5-inch electrical conduit through the levee authorized under Permit No. 1647, 1952 - Guiseppe and Emma D. Rosellini). [Additional References: DWR Levee Log, 1993. USACE Sacramento O&M Manual 104, February 1960, (RM 16.49)]. FS Date: 2/24/2014 | | | | | |

Pump on pier on WS slope.

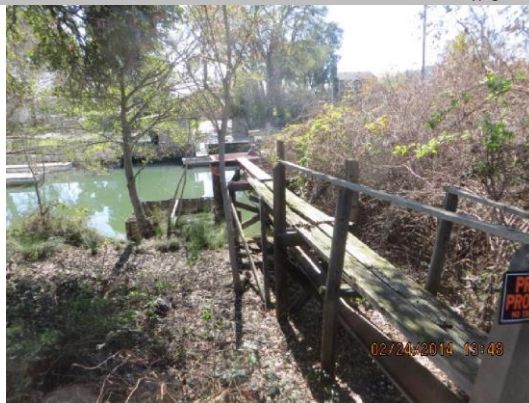
Photo 2 of 3 : UCIP_SP_2018_31083_56981.jpg

FS_ID:31083
DS_ID:22209
EP_NO: 1647
Repair Type: Non-Urgent
Crossing Status: Found
UCIP Comments: Sag in pavement over pipe on crown and wooden walkway to pump falling apart. Good candidate for video inspection.
FIELD_STRUCT_DESC: 10-inch steel irrigation discharge pipe through the levee, invert elevation 5.8 feet below the crown. Pump on a pile structure in the channel. Service pole on the landside (LS) slope. 1.5-inch electrical conduit through the levee, 3 feet below the crown. 42-inch concrete standpipe at the LS toe. (Plans for installing a 1.5-inch electrical conduit through the levee authorized under Permit No. 1647, 1952 - Guiseppe and Emma D. Rosellini). [Additional References: DWR Levee Log, 1993. USACE Sacramento O&M Manual 104, February 1960, (RM 16.49)].
FS Date: 2/24/2014

Pump on pier on WS slope. Wooden walkway failing.

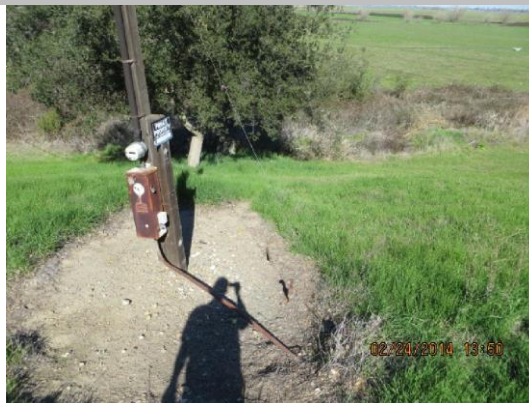
Photo 3 of 3 : UCIP_SP_2018_31083_56980.jpg

Meter on pole on LS slope.

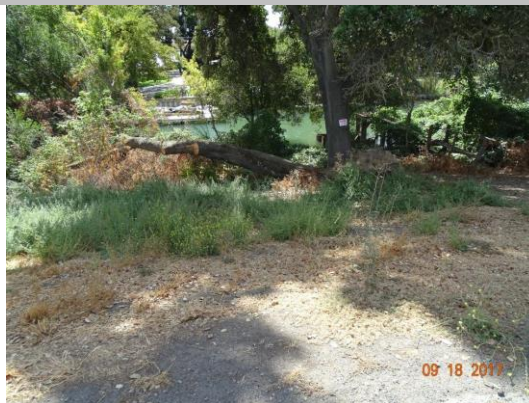
Photo 1 of 3 : SP_2018_RD0003_25_130_20180305_00096.jpg

| Fallen tree on waterside slope. | | | | | |

Looking south at the waterside slope.

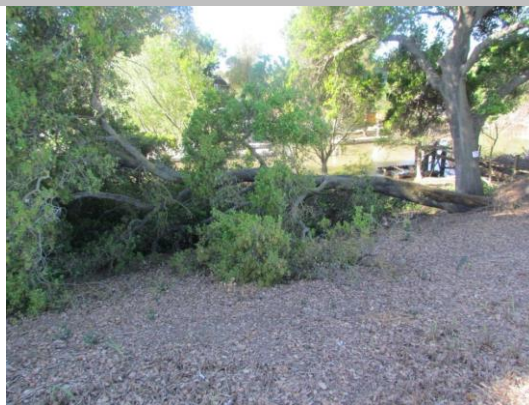
Photo 2 of 3 : SP_2018_RD0003_25_130_20180305_00097.jpg

Looking south at fallen tree on waterward slope.

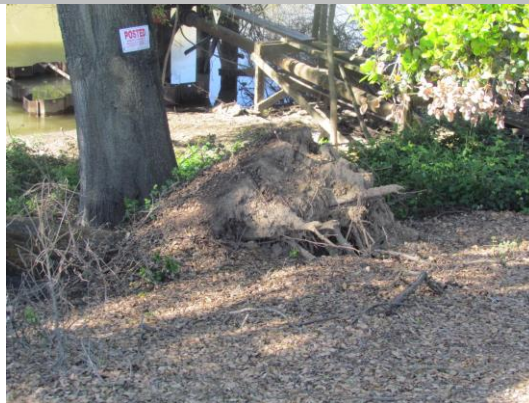
Photo 3 of 3 : SP_2018_RD0003_25_130_20180305_00098.jpg

Looking south at root ball of fallen tree on waterward slope.

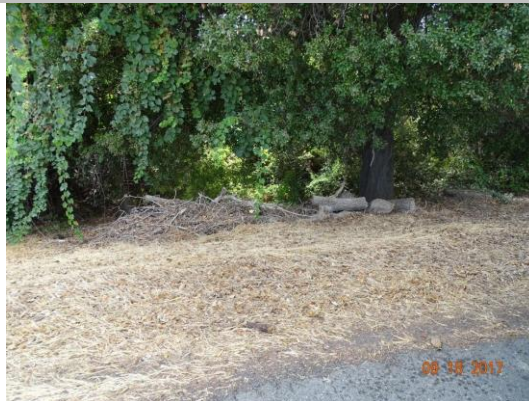
Photo 1 of 2 : SP_2018_RD0003_25_140_20180305_00112.jpg

| Prunings piles on waterside slope. | | | | | |

Looking south at the waterside slope.

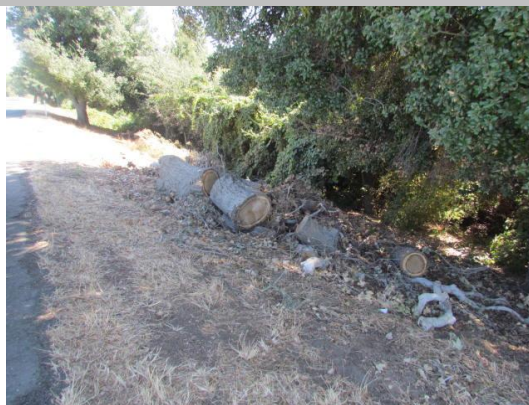
Photo 2 of 2 : SP_2018_RD0003_25_140_20180305_00113.jpg

Looking at tree branches and tree limbs on waterward shoulder and slope.

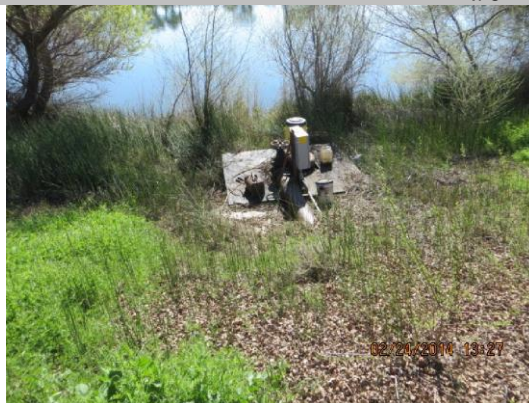
Photo 1 of 3 : UCIP_SP_2018_31026_56909.jpg

FS_ID:31026
DS_ID:22211
EP_NO: 2986
Repair Type: Non-Urgent
Crossing Status: Found
UCIP Comments: Trench over pipe on LS toe may indicate damage to pipe. Repair pipe and fill trench.
FIELD_STRUCT_DESC: 12-inch steel irrigation discharge pipe through the levee, 5 feet below the crown. Pump and gate valve on the waterside (WS) slope. 42-inch concrete standpipe at the landside (LS) toe. 1.5-inch steel electrical conduit through the levee at the same location. (Plans for installation of a pumping plant on the levee authorized under Permit No. 2986, 1959 - Ike Craven). [Additional Reference(s): DWR Levee Log, 1993. USACE Sacramento O&M Manual 104, February 1960, (RM 17.25), referenced as invert elevation 4 feet below the crown].
FS Date: 2/24/2014

Pump, pipe, gate valve, and electrical conduit visible on WS slope.

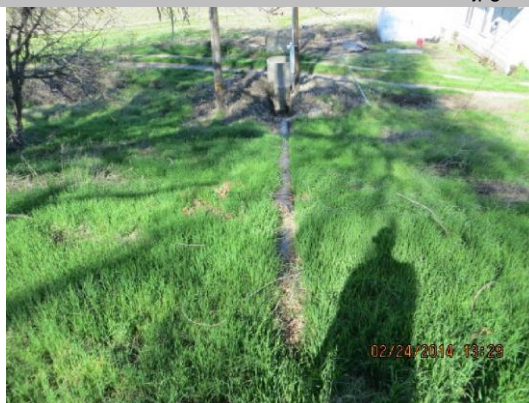
Photo 2 of 3 : UCIP_SP_2018_31026_56908.jpg

Pipe, meter, power pole, and concrete standpipe visible on LS slope/toe.

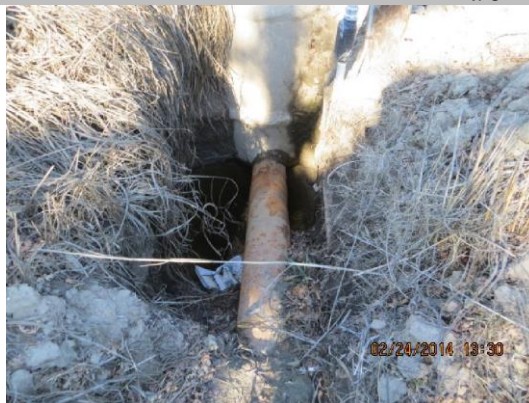
Photo 3 of 3 : UCIP_SP_2018_31026_56907.jpg

| FS_ID:31026 DS_ID:22211 EP_NO: 2986 Repair Type: Non-Urgent Crossing Status: Found UCIP Comments: Trench over pipe on LS toe may indicate damage to pipe. Repair pipe and fill trench. FIELD_STRUCT_DESC: 12-inch steel irrigation discharge pipe through the levee, 5 feet below the crown. Pump and gate valve on the waterside (WS) slope. 42-inch concrete standpipe at the landside (LS) toe. 1.5-inch steel electrical conduit through the levee at the same location. (Plans for installation of a pumping plant on the levee authorized under Permit No. 2986, 1959 - Ike Craven). [Additional Reference(s): DWR Levee Log, 1993. USACE Sacramento O&M Manual 104, February 1960, (RM 17.25), referenced as invert elevation 4 feet below the crown]. FS Date: 2/24/2014 | | | | | | |

Trench excavated over pipe at Standpipe/LS toe.

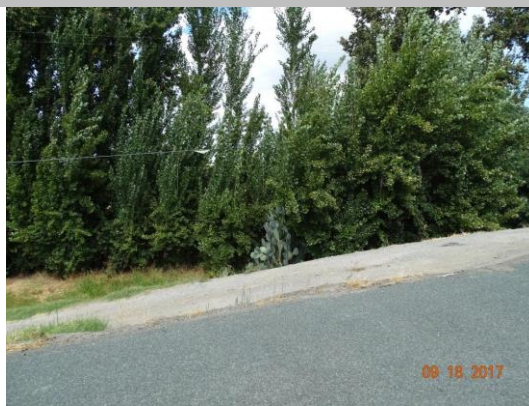
Photo 1 of 2 : SP_2018_RD0003_25_30_20180305_00031.jpg

| Cactus at landside toe and berm. | | | | | |

Looking north at the landside slope.

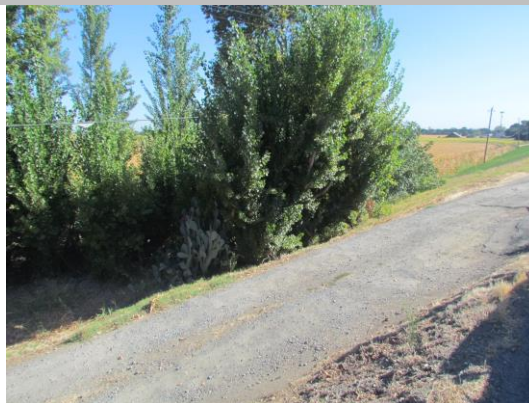
Photo 2 of 2 : SP_2018_RD0003_25_30_20180305_00032.jpg

| Cactus at landside toe and berm. | | | | | | |

Looking northeast at cactus and untrimmed trees at landward toe.

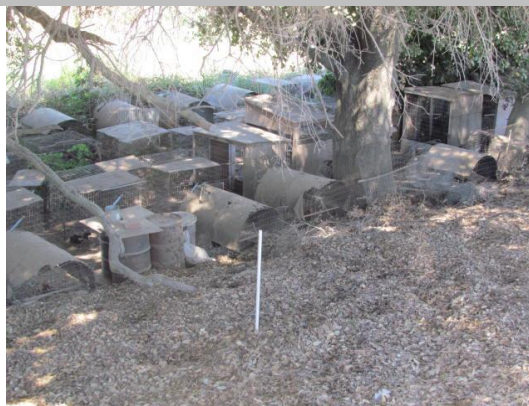
Photo 1 of 1 : SP_2018_RD0003_25_141_20180305_00114.jpg

| Chicken pens stored at landside toe. | | | | | |

Looking north at chicken pens at landward toe.

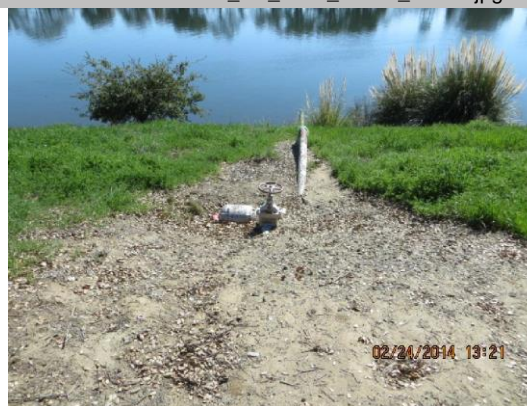
Photo 1 of 3 : UCIP_SP_2018_31025_56906.jpg

| FS_ID:31025 DS_ID:22212 EP_NO: 1289 Repair Type: Non-Urgent Crossing Status: Indicator Found UCIP Comments: Appears abandoned and if so should be done so properly. FIELD_STRUCT_DESC: *ABANDONED* 6-inch steel irrigation discharge pipe through the levee, invert elevation 4.5 feet below the crown. Pump and gate valve on the waterside (WS) slope. Service pole on the landside (LS) with a 1.5-inch electrical conduit through the levee at the same location. (Plans for installing an irrigation pumping plant and a 6-inch steel pipe through the levee authorized under Permit No. 1289, 1948 - Carlos Silva). [Additional Reference(s): DWR Levee Log, 1993. USACE Sacramento O&M Manual 104, February 1960, (RM 17.56)]. FS Date: 2/24/2014 | | | | | | |

Pipe, pump, and gate valve on WS slope.

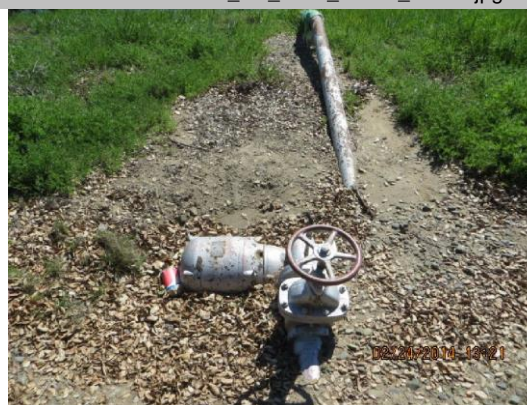
Photo 2 of 3 : UCIP_SP_2018_31025_56905.jpg

Pump and gate valve on WS slope.

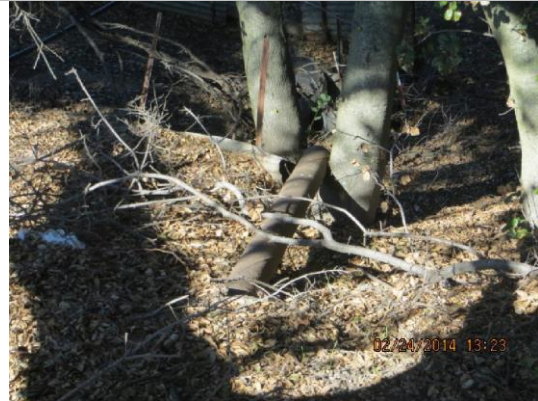
Photo 3 of 3 : UCIP_SP_2018_31025_56904.jpg

| FS_ID:31025 DS_ID:22212 EP_NO: 1289 Repair Type: Non-Urgent Crossing Status: Indicator Found UCIP Comments: Appears abandoned and if so should be done so properly. FIELD_STRUCT_DESC: *ABANDONED* 6-inch steel irrigation discharge pipe through the levee, invert elevation 4.5 feet below the crown. Pump and gate valve on the waterside (WS) slope. Service pole on the landside (LS) with a 1.5-inch electrical conduit through the levee at the same location. (Plans for installing an irrigation pumping plant and a 6-inch steel pipe through the levee authorized under Permit No. 1289, 1948 - Carlos Silva). [Additional Reference(s): DWR Levee Log, 1993. USACE Sacramento O&M Manual 104, February 1960, (RM 17.56)]. FS Date: 2/24/2014 | | | | | | |

Pipe on LS slope.

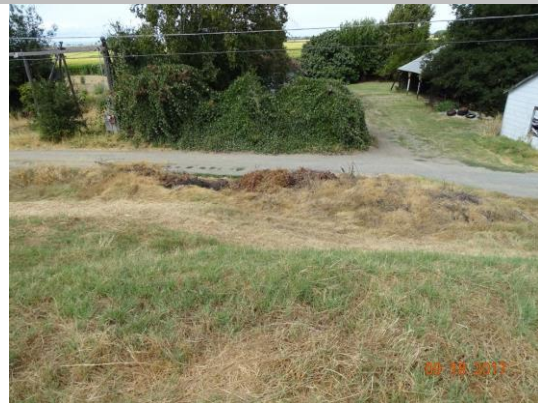
Photo 1 of 2 : SP_2018_RD0003_25_96_20180305_00082.jpg

| Pruning piles at landside toe. | | | | | |

Looking north at the landside slope.

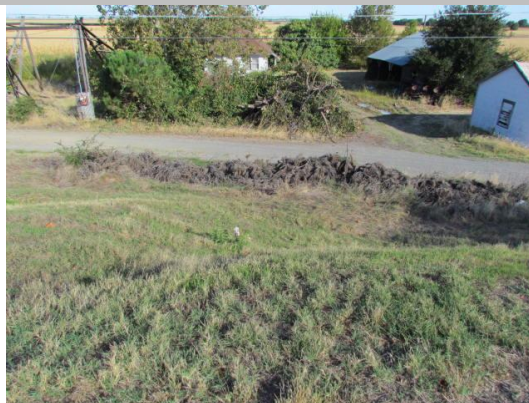
Photo 2 of 2 : SP_2018_RD0003_25_96_20180305_00083.jpg

| Pruning piles at landside toe. | | | | | | |

Looking west at pruning piles on landward toe.

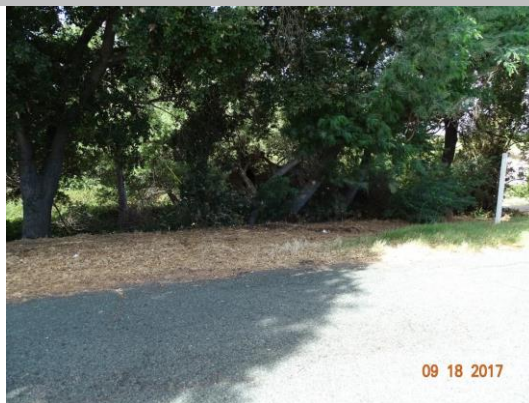
Photo 1 of 2 : SP_2018_RD0003_25_7_20180305_00009.jpg

| Dense vegetation on landside slope and toe. | | | | | |

Looking northwest at the landside slope.

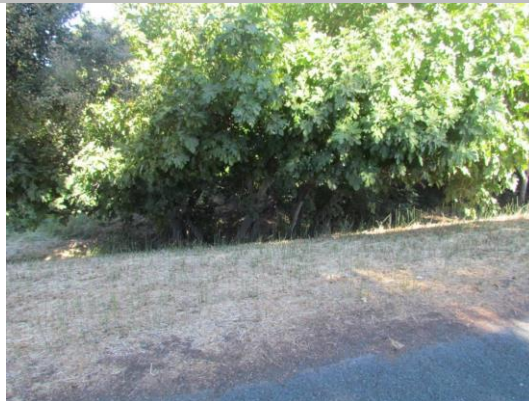
Photo 2 of 2 : SP_2018_RD0003_25_7_20180305_00010.jpg

Looking north at fig tree at landward toe.

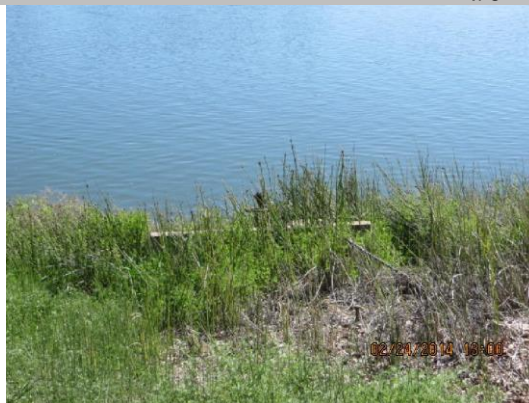
Photo 1 of 3 : UCIP_SP_2018_30983_56877.jpg

| FS_ID:30983 DS_ID:22217 EP_NO: N/A Repair Type: Non-Urgent Crossing Status: Found UCIP Comments: Pipe appears abandoned and if so should be done so properly. FIELD_STRUCT_DESC: 6-inch steel irrigation discharge pipe through the levee, invert elevation 3.5 feet below the crown. Pump and gate valve on a concrete pad on the waterside (WS) slope. Meter pole at the landside (LS) toe with a 1.5-inch electrical conduit through the levee at the same location. (Lillie). [Additional Reference(s): DWR Levee Log, 1993. USACE Sacramento O&M Manual 104, February 1960, (RM 18.17)]. FS Date: 2/24/2014 | | | | | | |

Pump on concrete platform on WS slope.

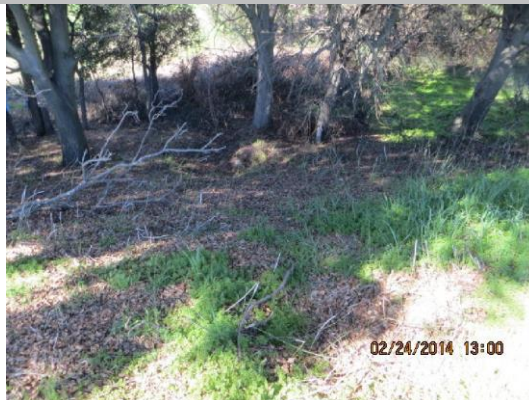
Photo 2 of 3 : UCIP_SP_2018_30983_56876.jpg

Pipe visible at LS toe.

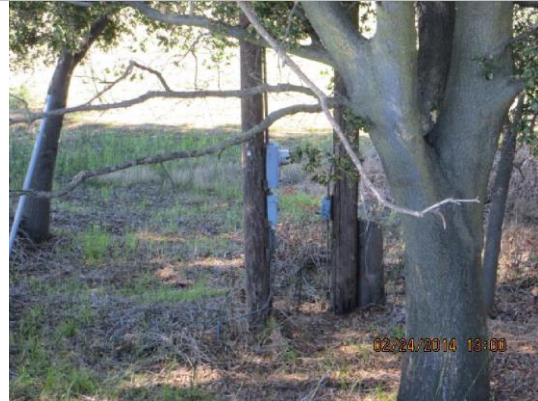
Photo 3 of 3 : UCIP_SP_2018_30983_56875.jpg

Meter on powerpole on LS toe.

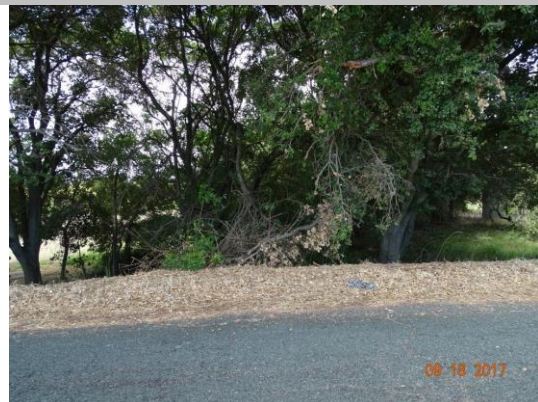
Photo 1 of 1 : SP_2018_RD0003_25_154_20180305_00134.jpg

| Downed tree on landside slope. | | | | | |

Looking northwest at the landside slope.

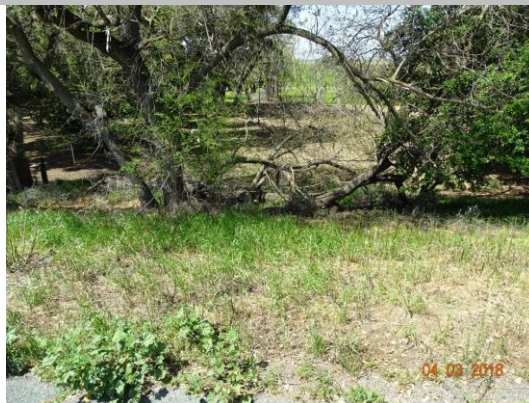
Photo 1 of 1 : SP_2018_RD0003_25_180_20180403_00284.jpg

| Fallen tree at landside toe blocks access. | | | | | |

Fallen tree at landside toe should be removed.

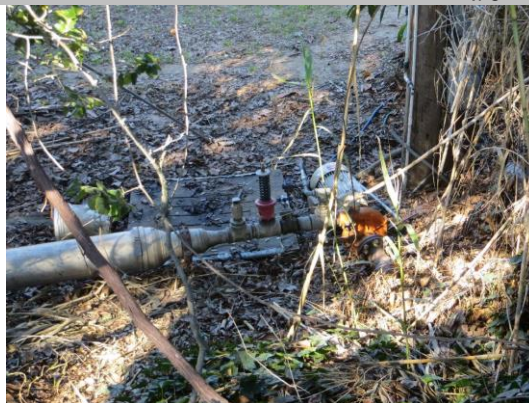
Photo 1 of 3 : UCIP_SP_2018_30963_56862.jpg

| FS_ID:30963 DS_ID:22221 EP_NO: 1283 Repair Type: Non-Urgent Crossing Status: Indicator Found UCIP Comments: Permit for 12-inch pipe and pump on pier. Unable to identify permit for 6-inch pipe. FIELD_STRUCT_DESC: 12-inch steel irrigation discharge pipe through the levee, invert elevation 6 feet below the crown. Pump, shutoff valve, power pole, and vent at the landside (LS) toe. 6-inch steel pipe appears to be sleeved through the 12-inch pipe. 1.5-inch steel electrical conduit at the same location. (Plans for installing a pumping plant and a 12-inch pipe through the levee authorized under Permit No. 1283, 1948 - Manuel E. and Frank E. Silva). [Additional Reference(s): DWR Levee Log, 1993. USACE Sacramento O&M Manual 104, February 1960, (RM 18.66)]. FS Date: 2/24/2014 | | | | | | |

Pump, shutoff, power pole, and vent on LS toe.

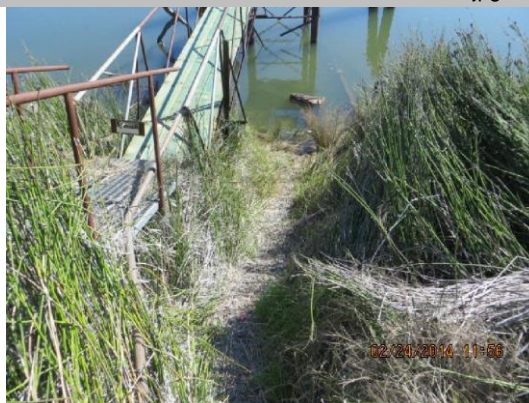
Photo 2 of 3 : UCIP_SP_2018_30963_56861.jpg

Pipe visible to right of walkway on LS slope and in water.

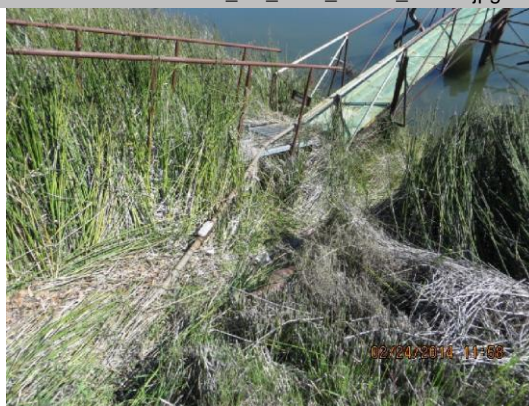
Photo 3 of 3 : UCIP_SP_2018_30963_56860.jpg

Pipe visible to right of walkway on LS slope.

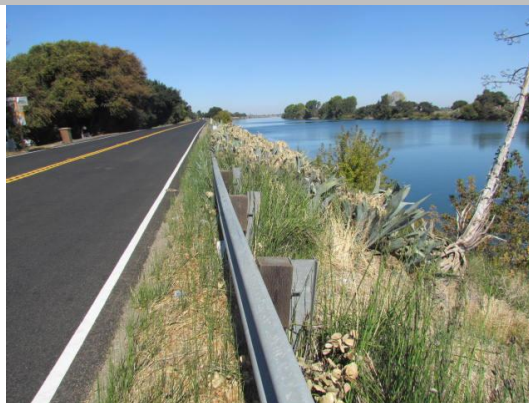
Photo 1 of 1 : SP_2018_RD0003_25_145_20180305_00121.jpg

| Century plants on waterside shoulder and slope. | | | | | |

Looking northeast at century plants on waterward shoulder and slope.

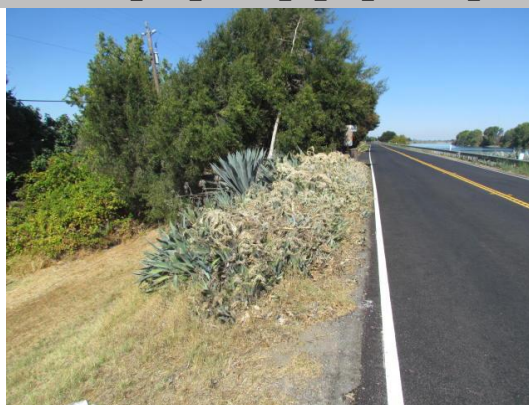
Photo 1 of 1 : SP_2018_RD0003_25_143_20180305_00118.jpg

| Large century plants on landside shoulder and slope. | | | | | |

Looking north at century plants on landward shoulder and slope.

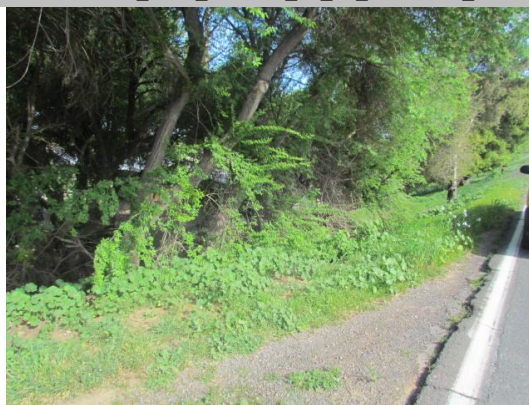
Photo 1 of 1 : SP_2018_RD0003_25_48_20180305_00041.jpg

Looking southwest at dense trees on landward slope.

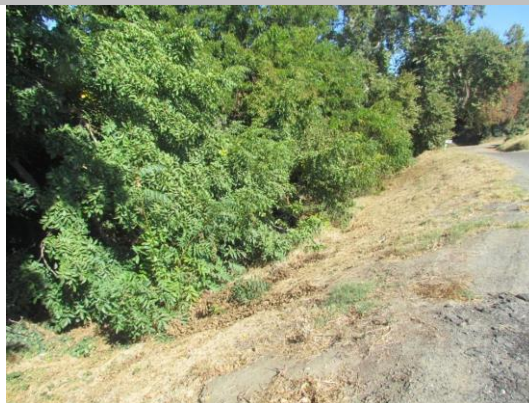
Photo 1 of 2 : SP_2018_RD0003_25_10_20180305_00013.jpg

Looking north at untrimmed trees on landward slope and toe. (Fall 2016)

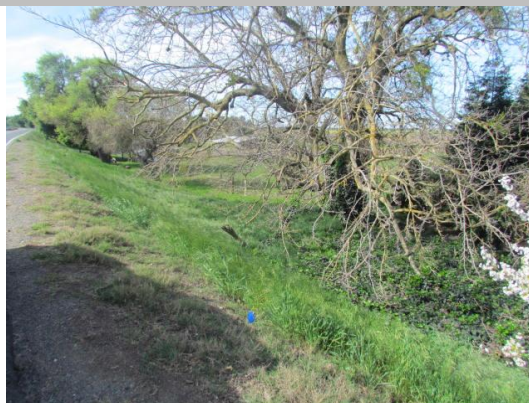
Photo 2 of 2 : SP_2018_RD0003_25_10_20180305_00014.jpg

Looking west at untrimmed tree on landward slope. (Spring 2016)

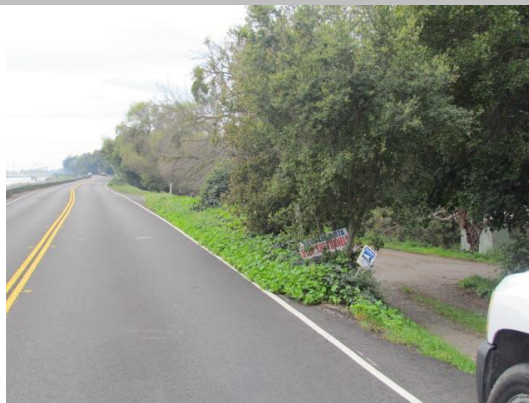
Photo 1 of 2 : SP_2018_RD0003_25_92_20180305_00078.jpg

| Ground cover, palm tree and other vegetation blocking view of landside slope and toe. | | | | | |

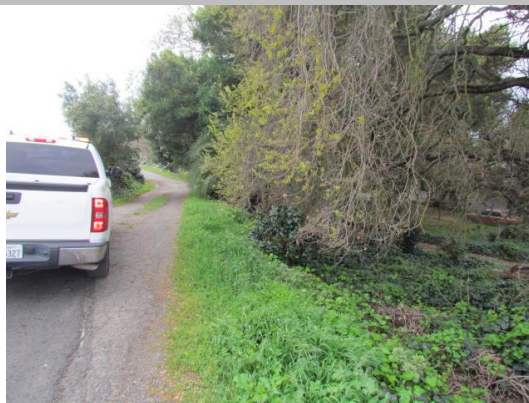
Photo 2 of 2 : SP_2018_RD0003_25_92_20180305_00079.jpg

| Ground cover, palm tree and other vegetation blocking view of landside slope and toe. | | | | | |

Looking south at groundcover and other vegetation on landward slope.
